Structural Assessment of Collapsed Building

Date of Observation: March 10, 2022

Location: Building Collapse
102 McNatt Avenue
Aurora, MO 65605

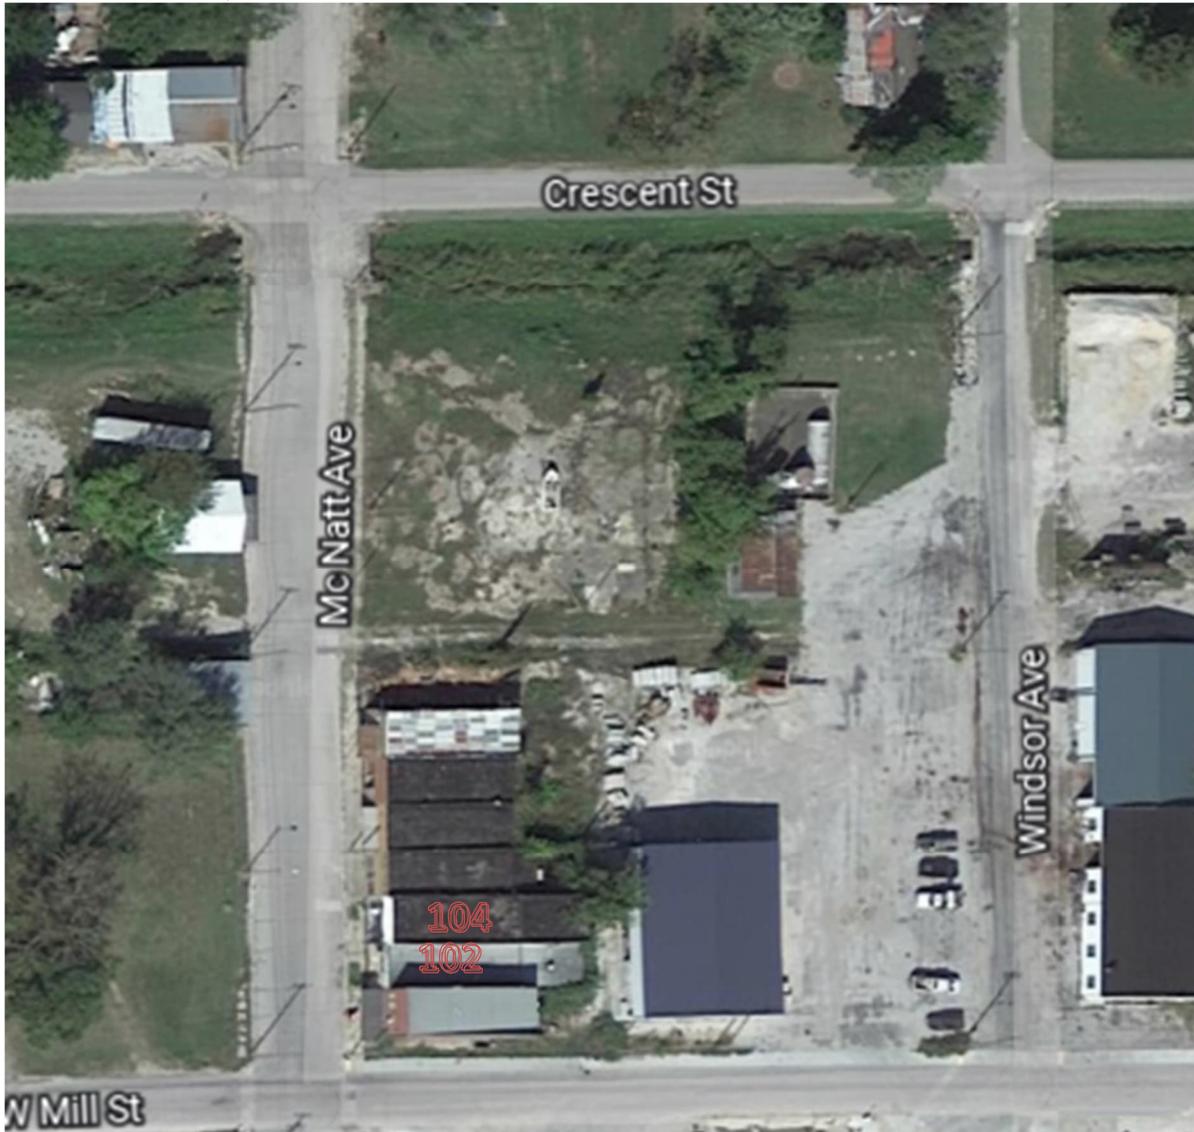
Picture 1

Overview: The buildings 102 and 104 have collapsed in the front. Building 100 is still standing and was used as a rental apartment and was occupied during the collapse. No injuries were reported. The city has barricaded the half of E. Mill St. and Mc Natt Ave. and have blocked the entrance to building 100 for public safety and has requested this structural analysis and recommendations on further action needed to ensure public safety.

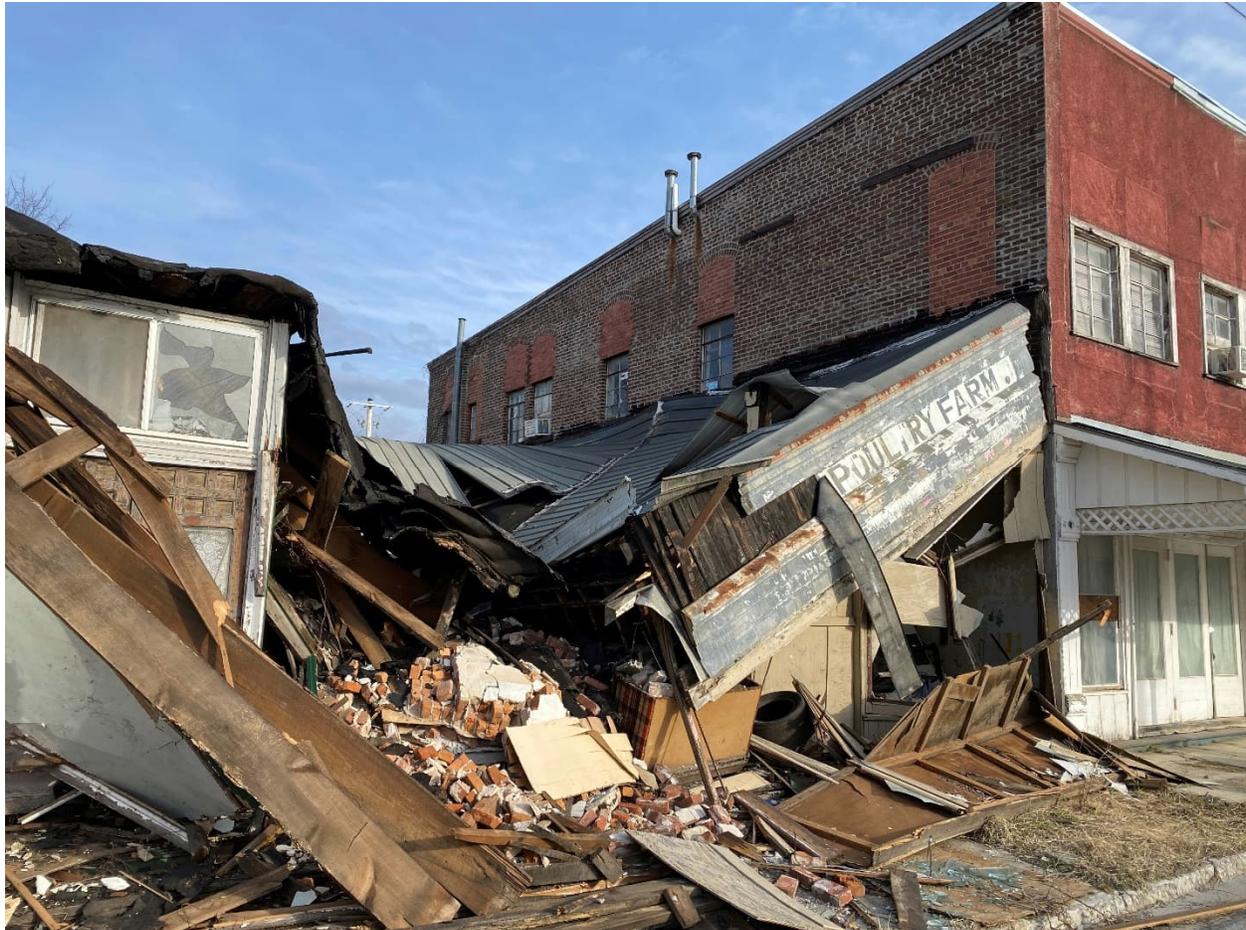
Picture 2 – Looking SE at 102 & 104

Observations and Discussions: It is our understanding that 102 and 104 collapsed sometime during the evening hours of Tuesday, February 16th, 2022. During the on-site inspection on Thursday March 10th, one of the tenants of the second story of 100 told us that he was flung out of bed during the collapse. He also reported that he had to walk up a slight incline to reach the north wall of his apartment. The tenant's account of his experience is consistent with the collapse of the adjacent building where the failure of the joints would pivot in the wall thereby causing an uplift in the north edge of the floor in 100 McNatt. This is also consistent with the wider gap seen in the flashing (Picture 11) at the north end of the front wall. Because this wall has been pushed upward, any continuation of load transfer in the wall is disrupted and would no longer be considered stable. The wall standing between 100 and 102 seems to have bowed and is lifting

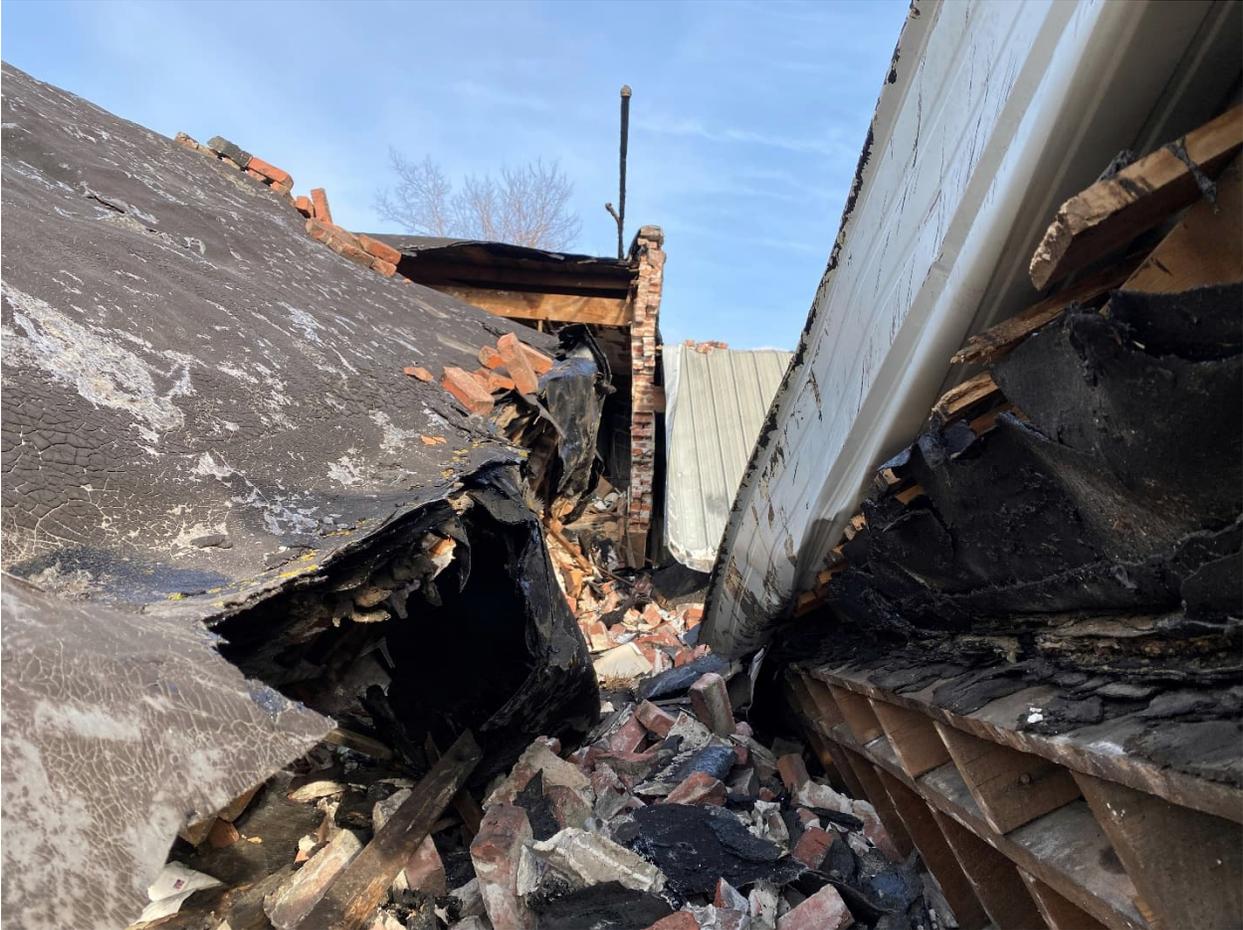
2nd story of 100 up. It appears some of the boards were burned in 102. The back of half of the party wall between 102 and 104 was still standing but is no longer straight or plumb.

Picture 3 – Party Wall between 102/104

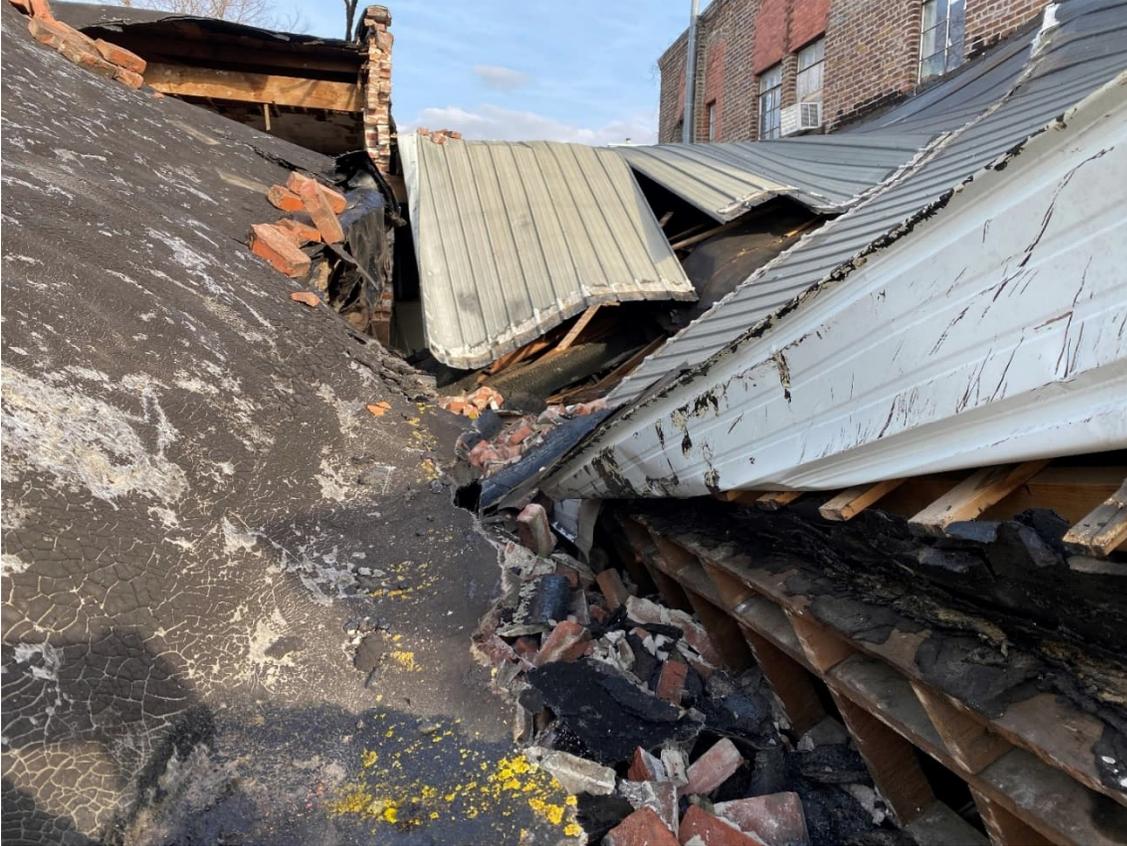
Picture 4 – Burnt boards in 102

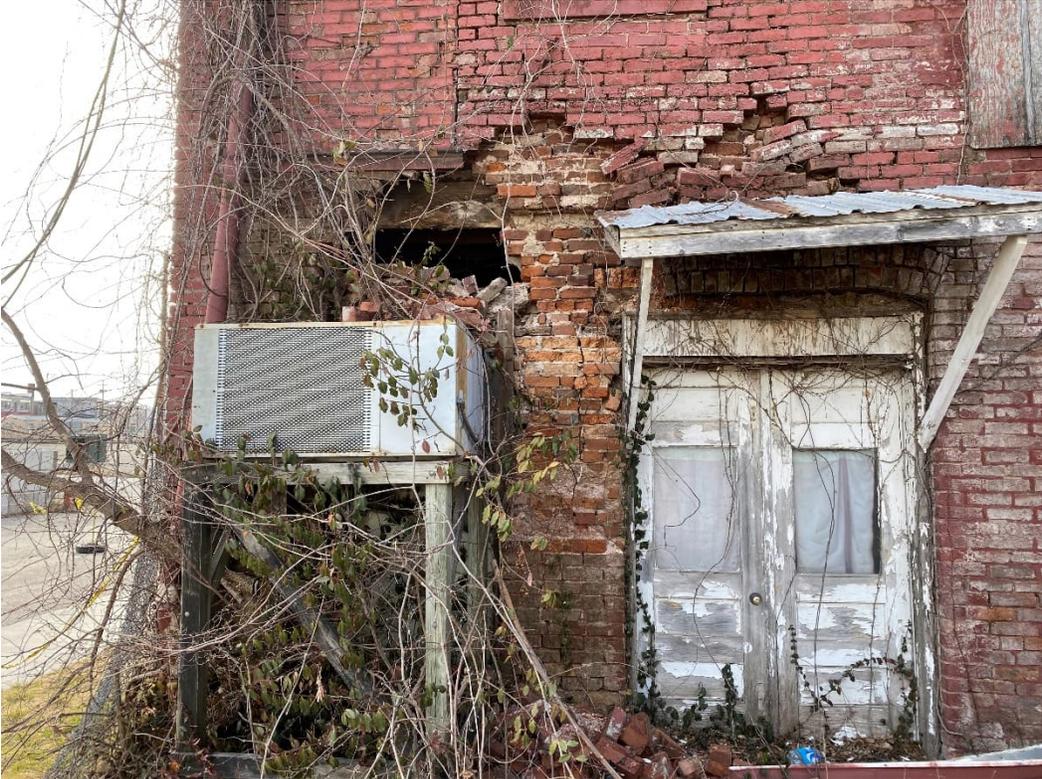
As shown in the photographs, the condition of the buildings has deteriorated significantly resulting in structural stability. The bricks in the back wall of 100 McNatt are dislocated and the arches are flattened, settled, and partially collapsed resulting in further structural instability.

Picture 5 – Backside of Unit 100 1st floor

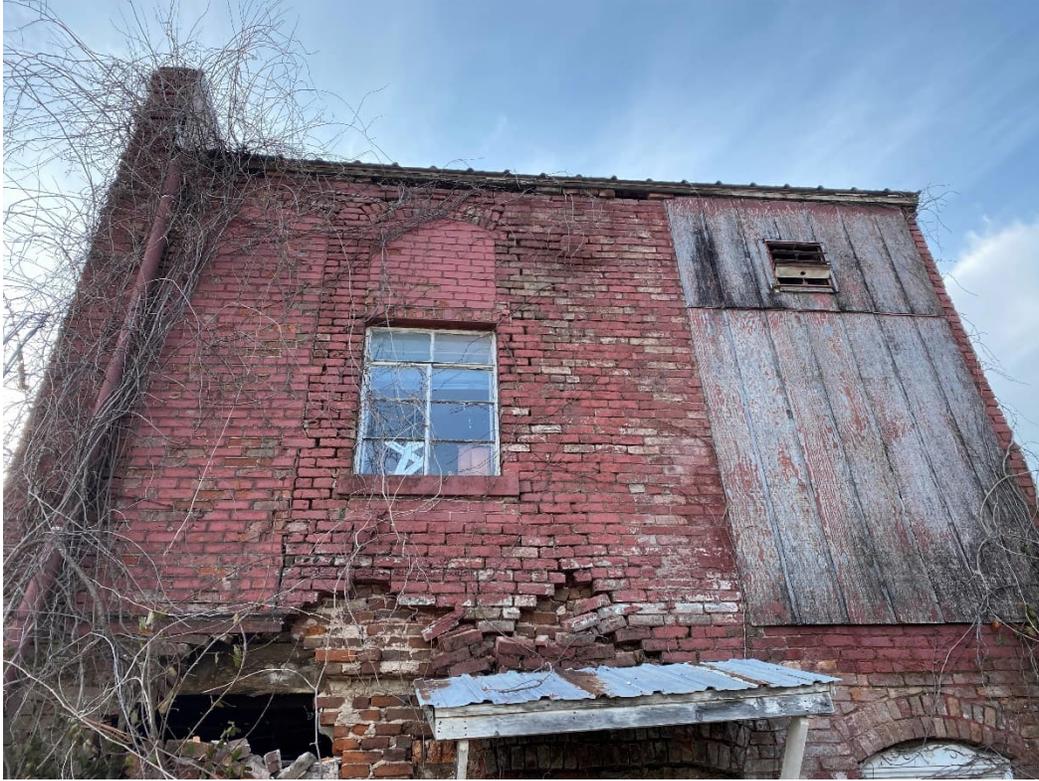
Picture 6 – Back of Unit 100 2nd floor

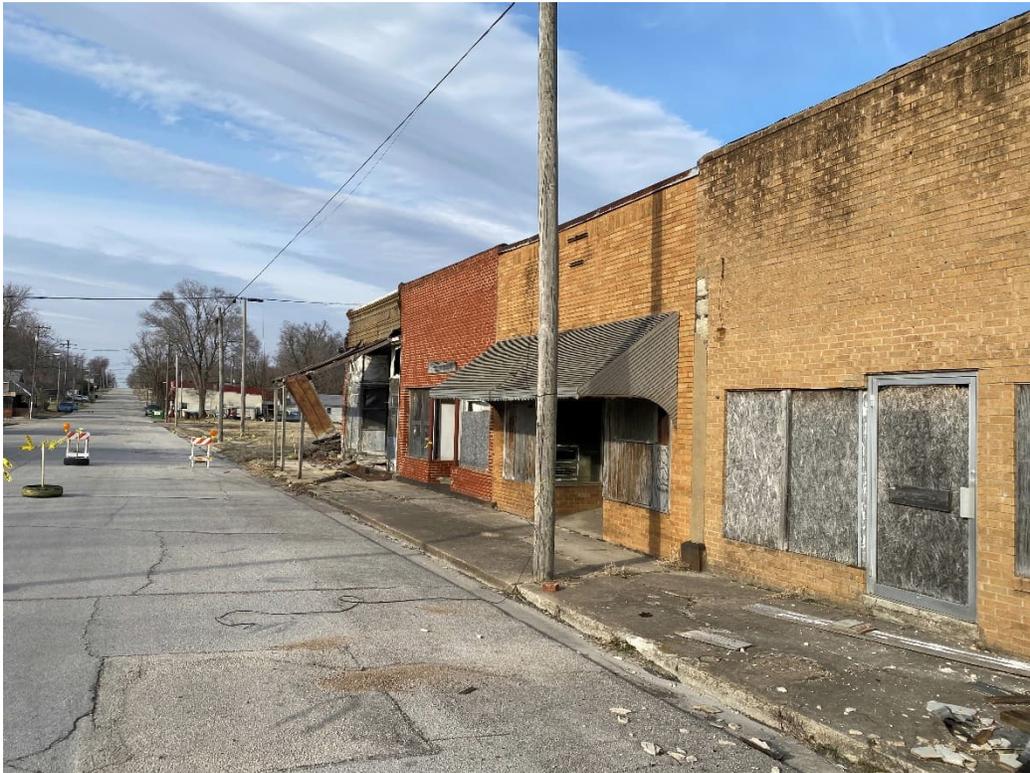
Picture 7 – Looking Northeast Towards the front of Lots 4-8

Due to the advanced deterioration and lack of maintenance of the buildings and the structural instability caused by the collapse of 102 and 104, it is the recommendation of this office that all buildings between and including Lots 4 through 11, (Address 100 through 114 McNatt Avenue), be demolished as soon as possible for public health and safety. This is the most economical option investigated.

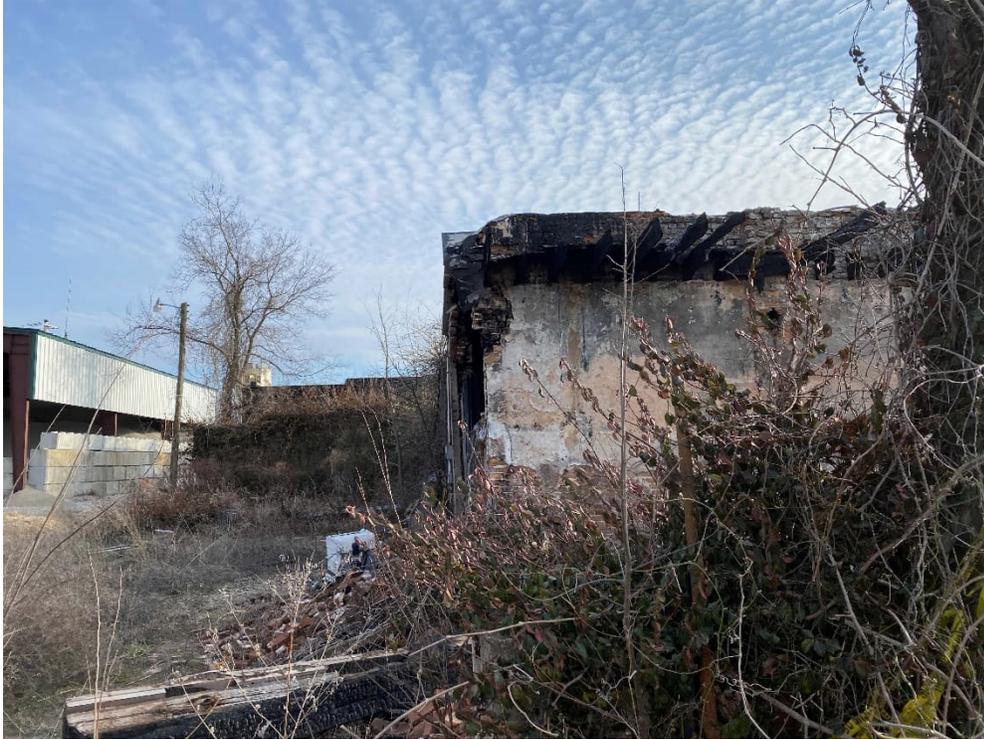
Picture 8 – Looking South Towards the back of Lots 4-8

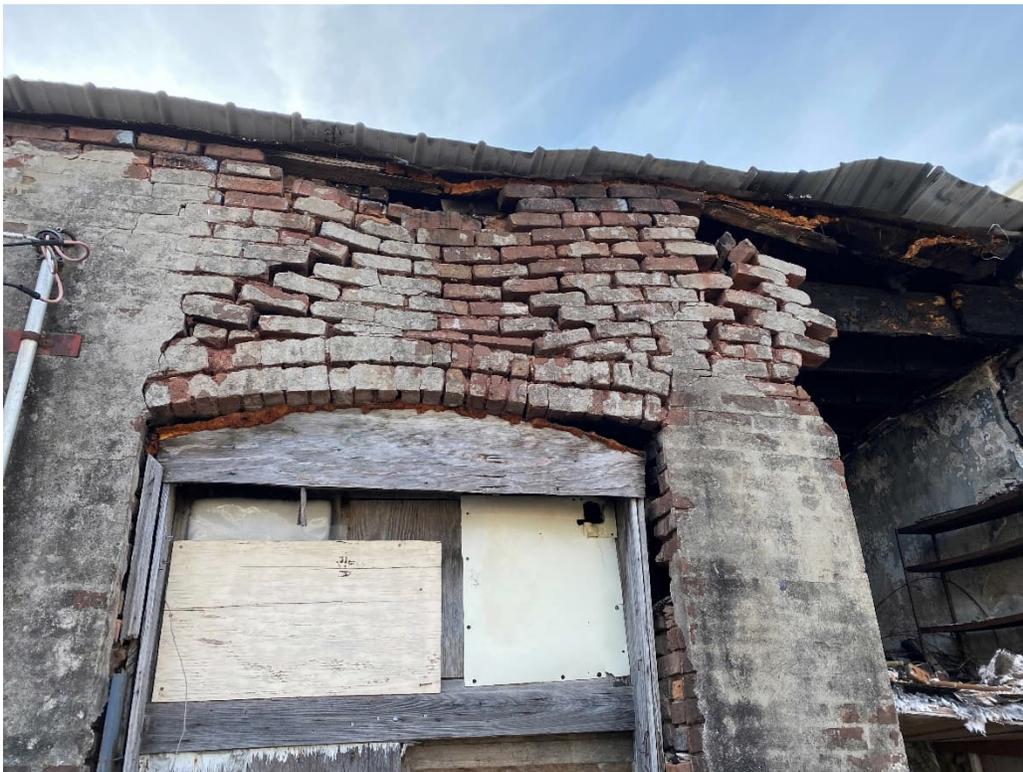
Picture 9 – Back side of Lot 5

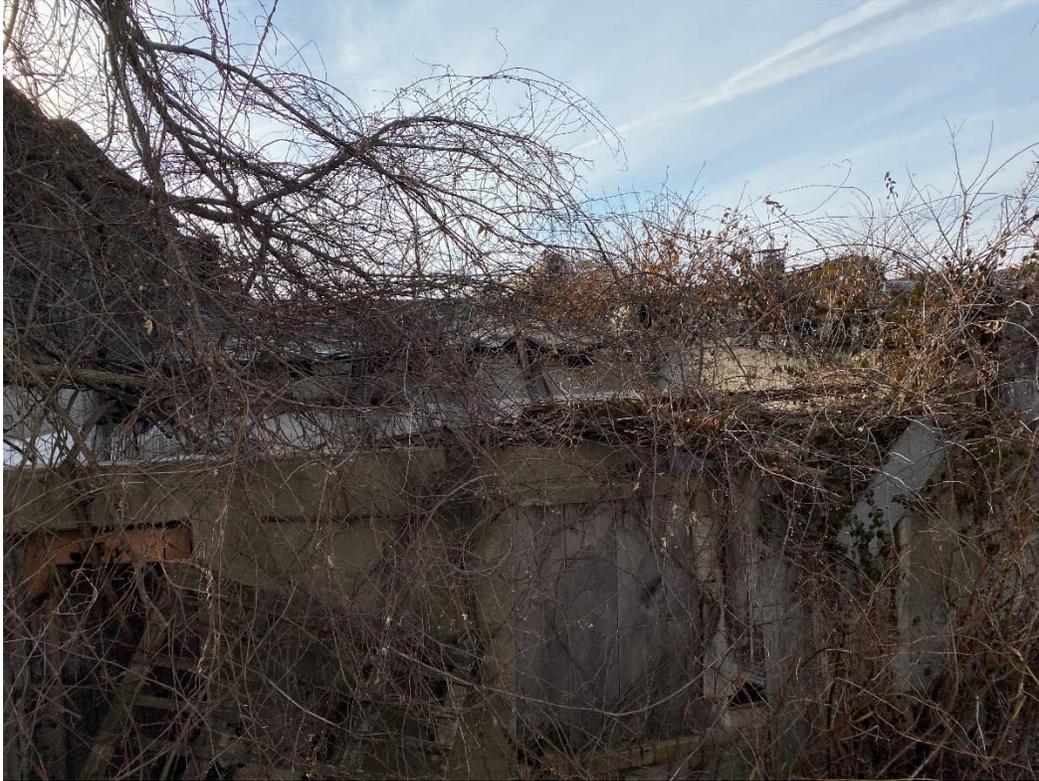
Picture 10 – Back side of Lot 7

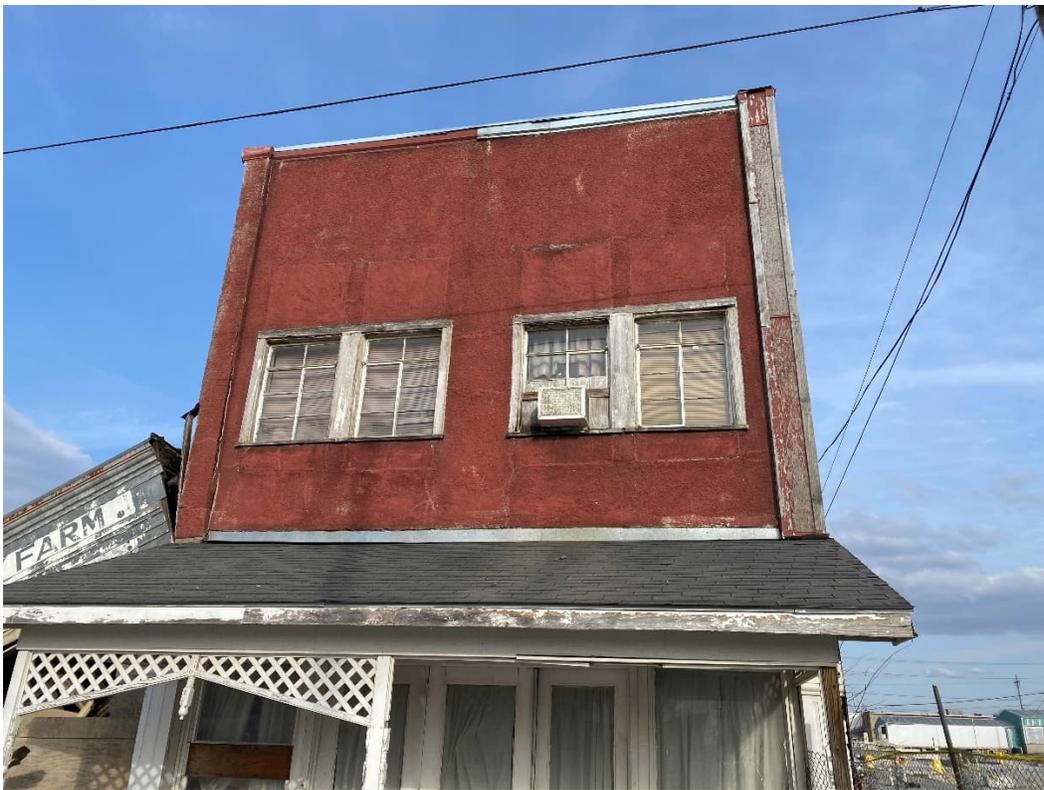
Picture 11 – Front of Unit 100, 2nd Floor Flashing
