Structural Assessment of Historic Building

Location: 307 & 309 S. Madison Ave.
Aurora, MO 65605

Date of Observations: October 30, 2019 Interior and Exterior
November 8, 2019 Exterior Only

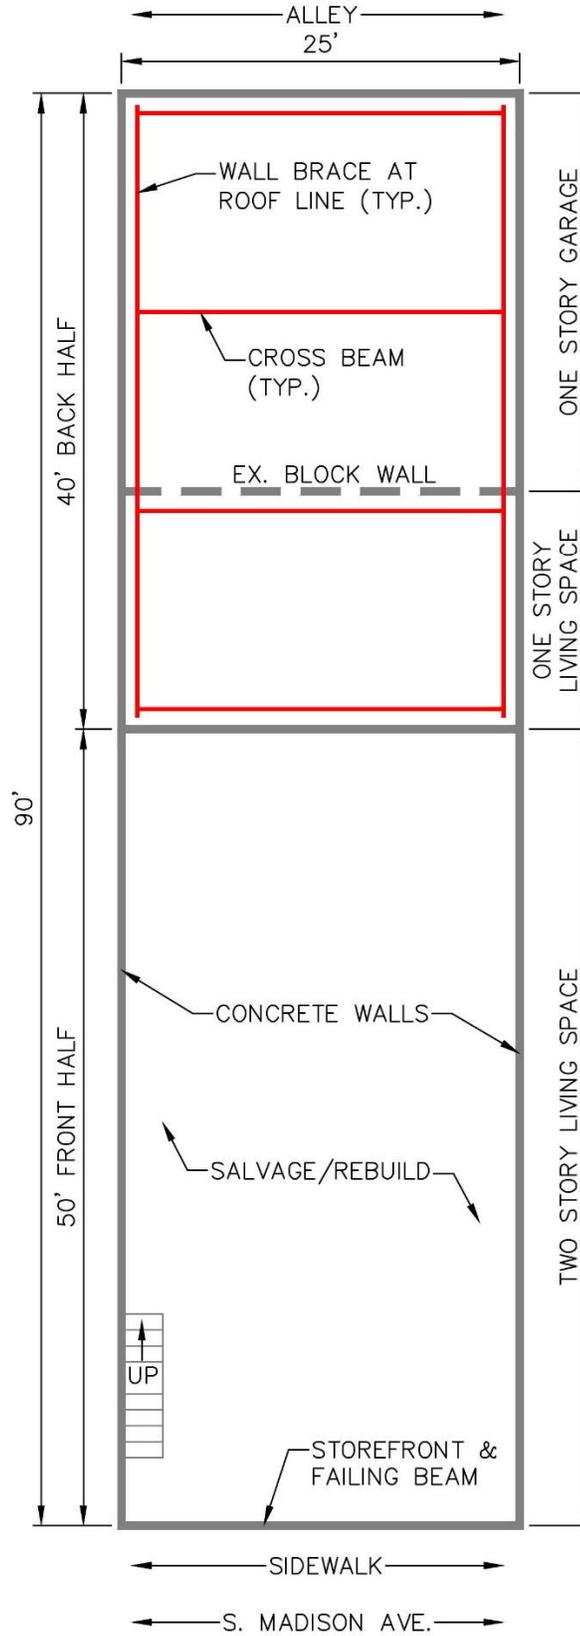
GENERAL DRAWING

1. The front half (east half) of the building is two-story and in salvageable condition. The roof is leaking and needs addressed soon to prevent further damage to the walls and floors below. The masonry/concrete beam over the storefront windows is failing and needs supported or replaced.
2. The back half (west half) of the building is one-story with a section used as a garage and a section used as living space. The roof is entirely missing from the garage area and mostly missing on the living area. The roof needs replaced with a new roof or bracing as shown on the general drawing. The floor is unsalvageable in the living space and should be removed.

2. It is recommended that the back half of the building be mostly demolished by removing roof and floor remnants. Both of the shared load bearing walls are braced by the floors and roof which act as diaphragms. With these wood framing members compromised the masonry walls are not supported well laterally. Installation of steel bracing for the shared walls is required if the roof structure is not reconstructed. The block cross wall can remain if properly waterproofed. See general drawing.

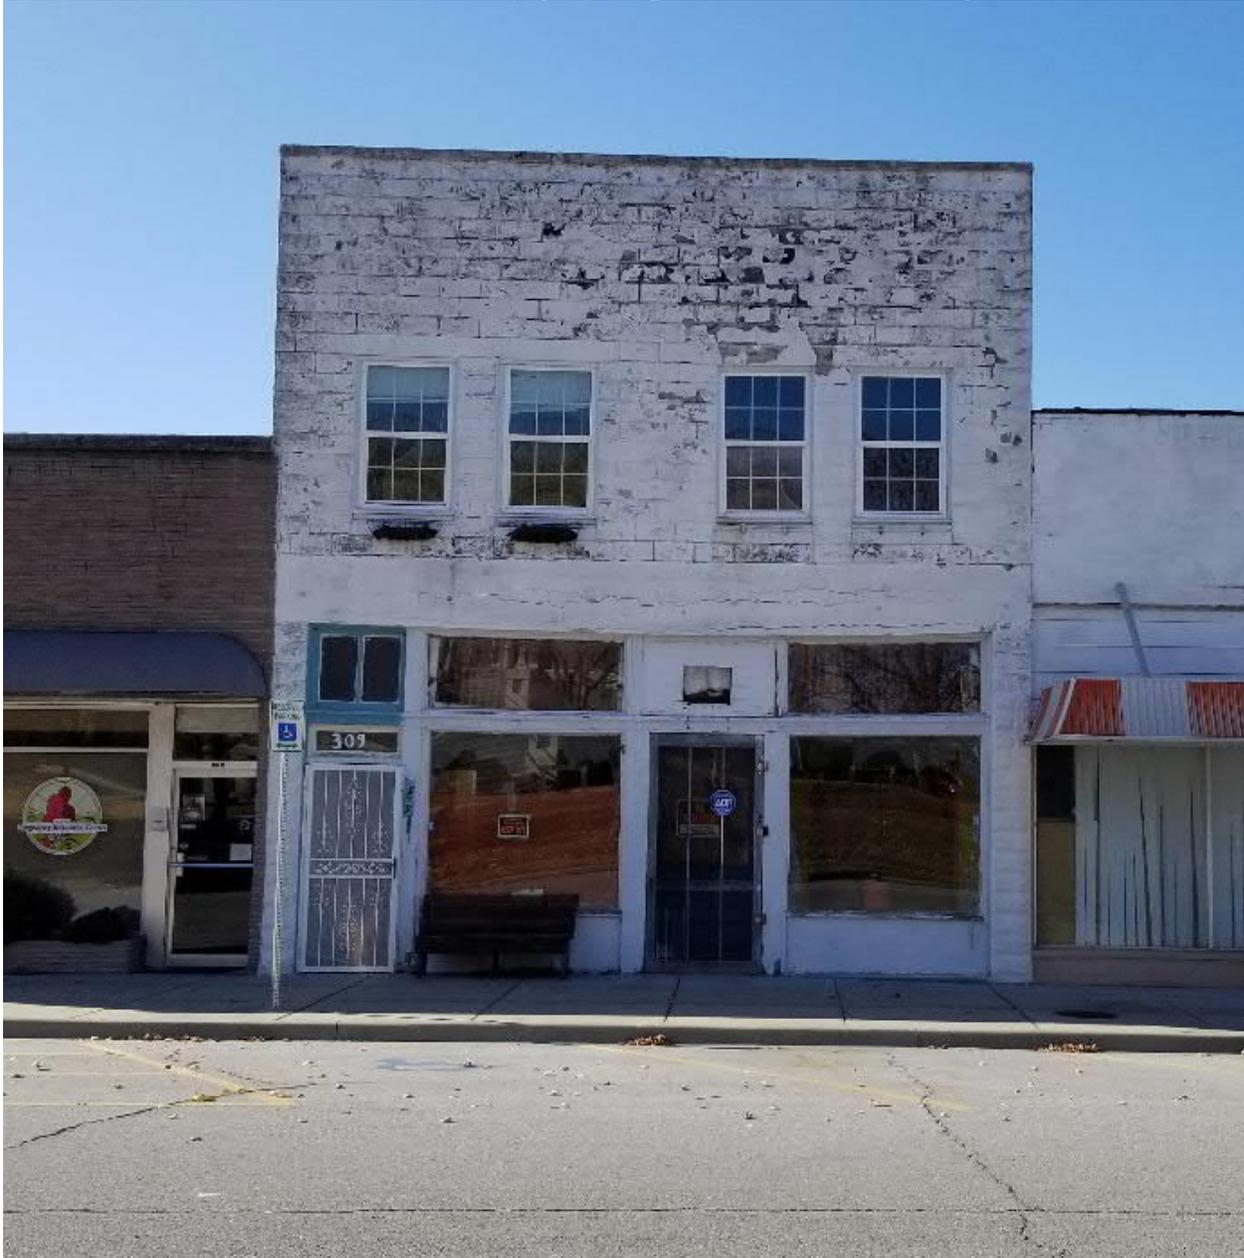
Overall view from the front: white two-story building in the center is the subject structure.

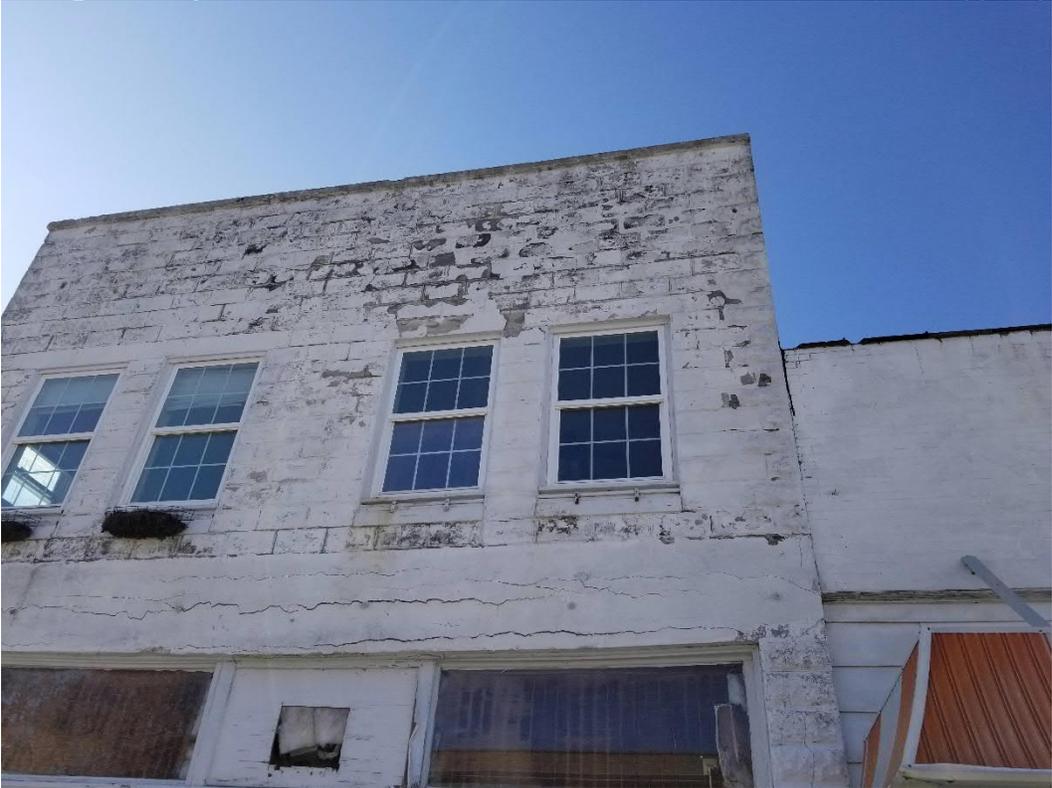
Failing masonry/concrete beam over storefront and cast concrete beam support/party wall.

3. If the property owner intends to salvage the front half, it is recommended that the property owner select a qualified contractor experienced in salvaging and remodeling buildings of this nature to perform the required repairs to the front half of the building. Before any other work is conducted the failing masonry/concrete beam should be replaced, or supported with a new beam and columns. The masonry wall above it imposes significant dead load on the very deteriorated masonry/concrete beam. Once the masonry/concrete beam is supported, begin working on the roof joists by replacing or installing sister joists. Repair the roof, skylights, and parapet to stop leaks. Once the leaks are stopped, the contractor can make necessary repairs to the floors and walls.

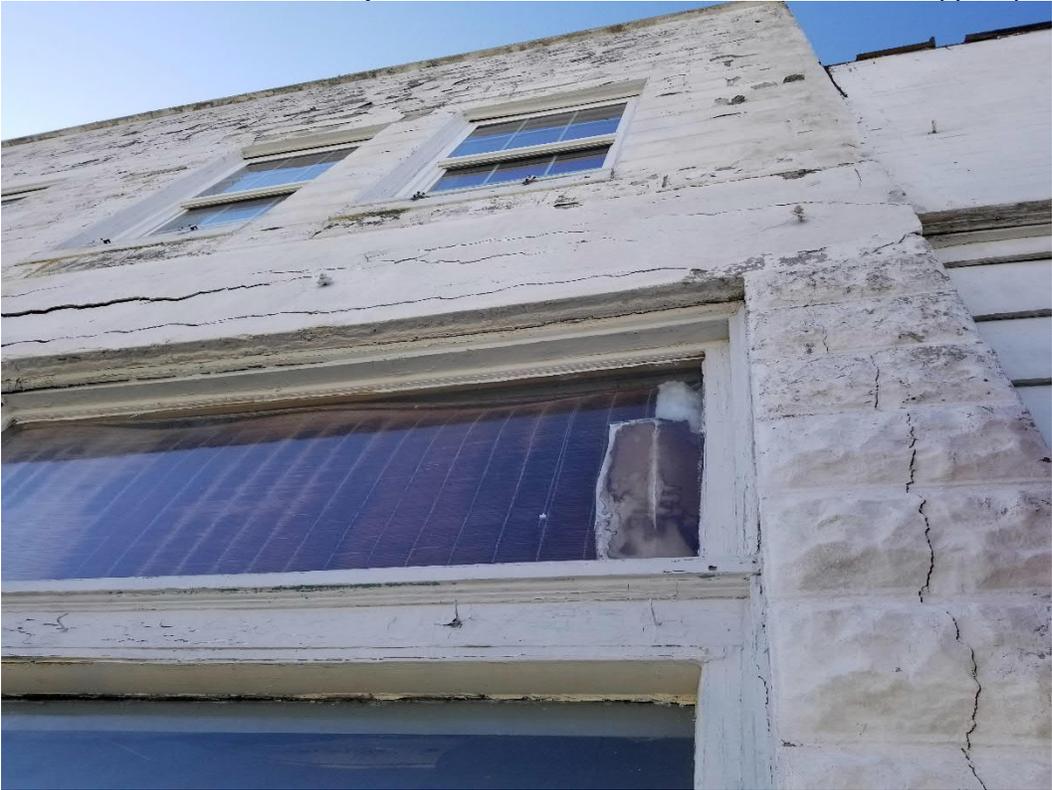
Closer look at same masonry/concrete beam and cast concrete beam support/party wall.

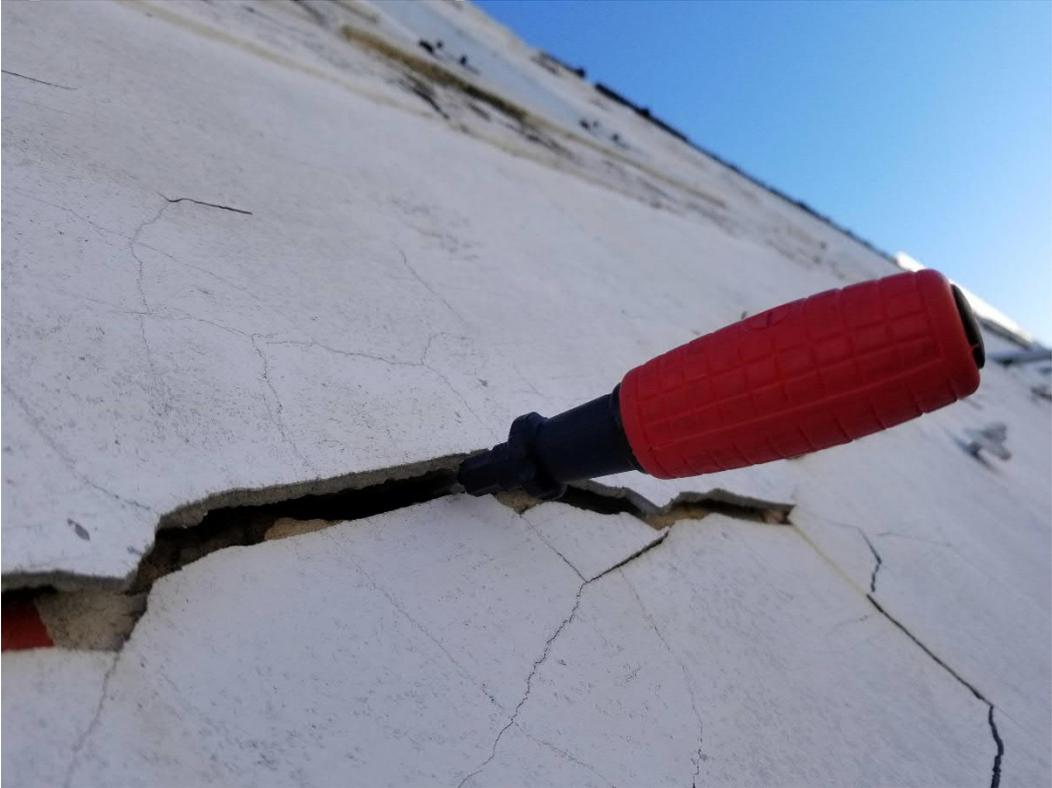
Significant horizontal beam cracking.

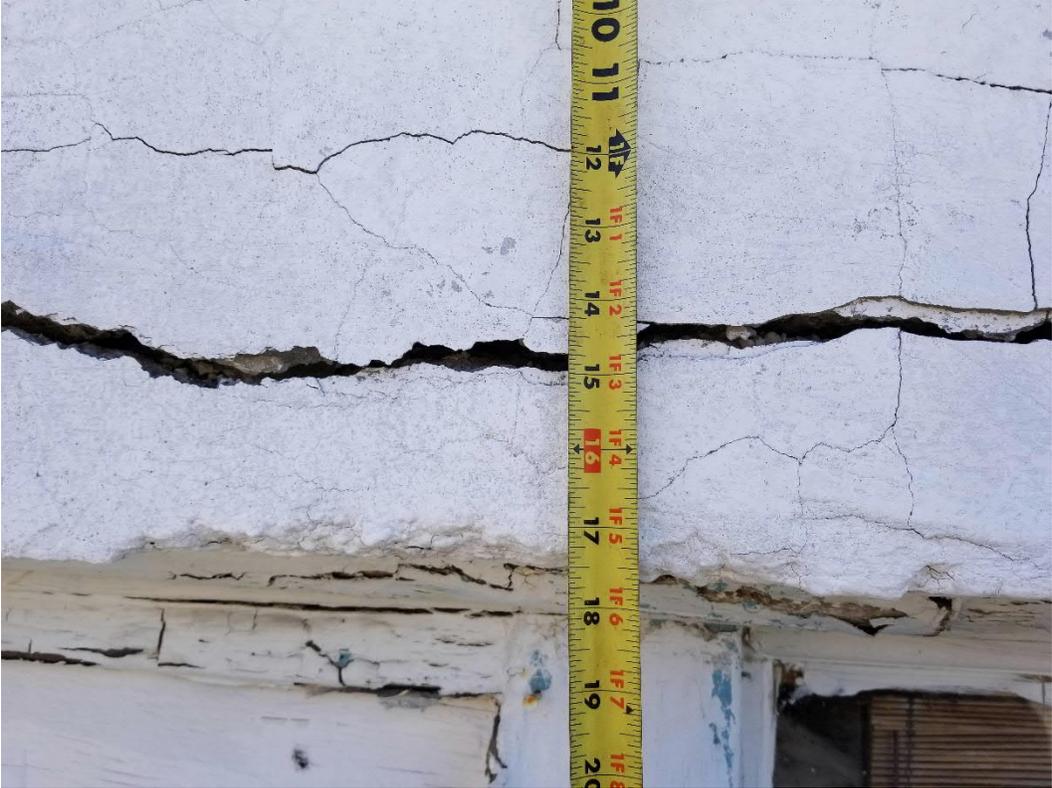
Crack separation measurement.

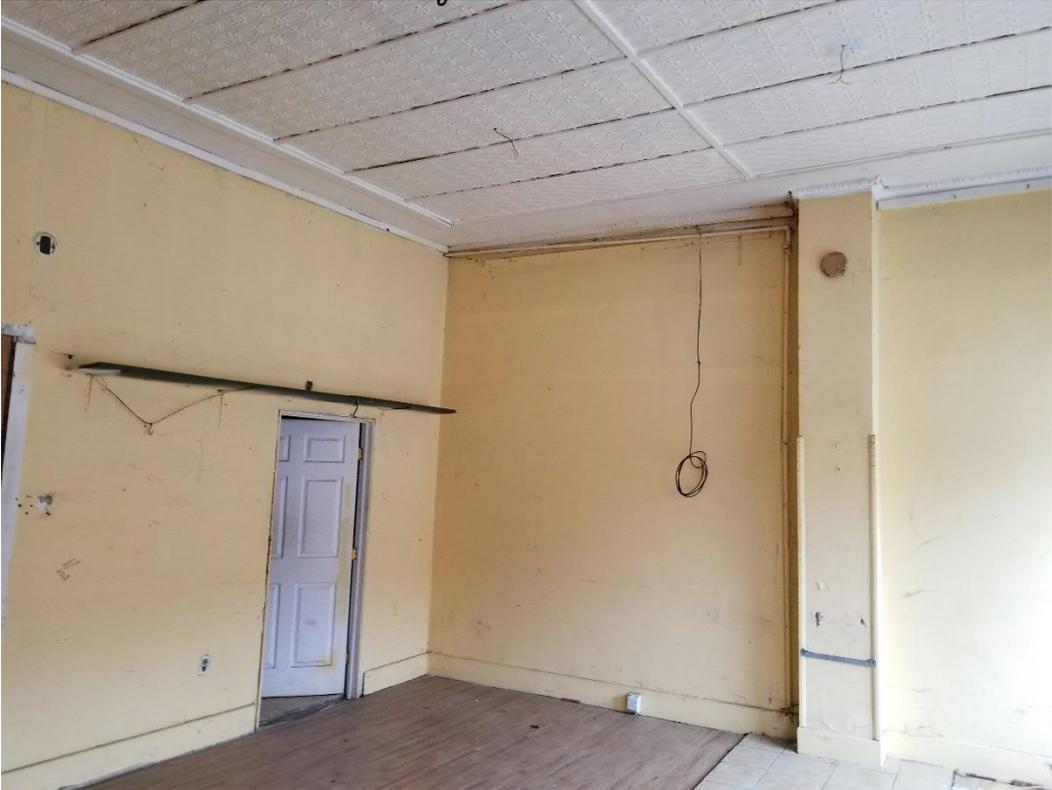
Looking in from front entrance at the front room, lower level.

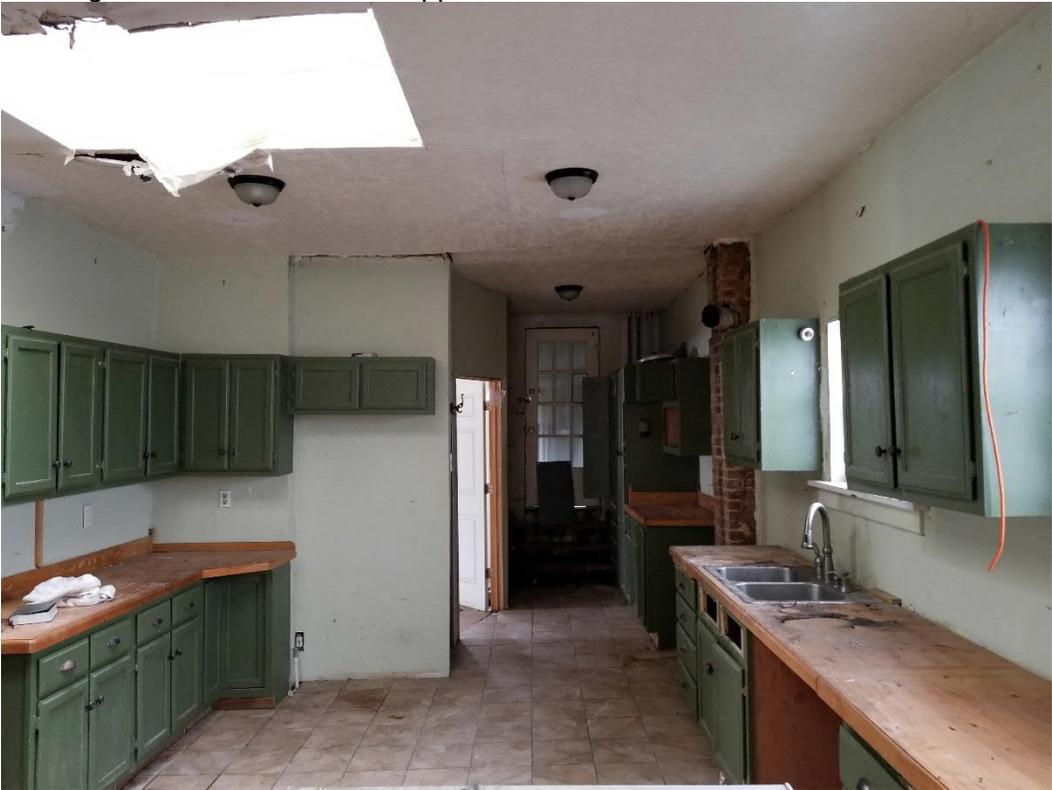
Looking toward the back in the upper level.

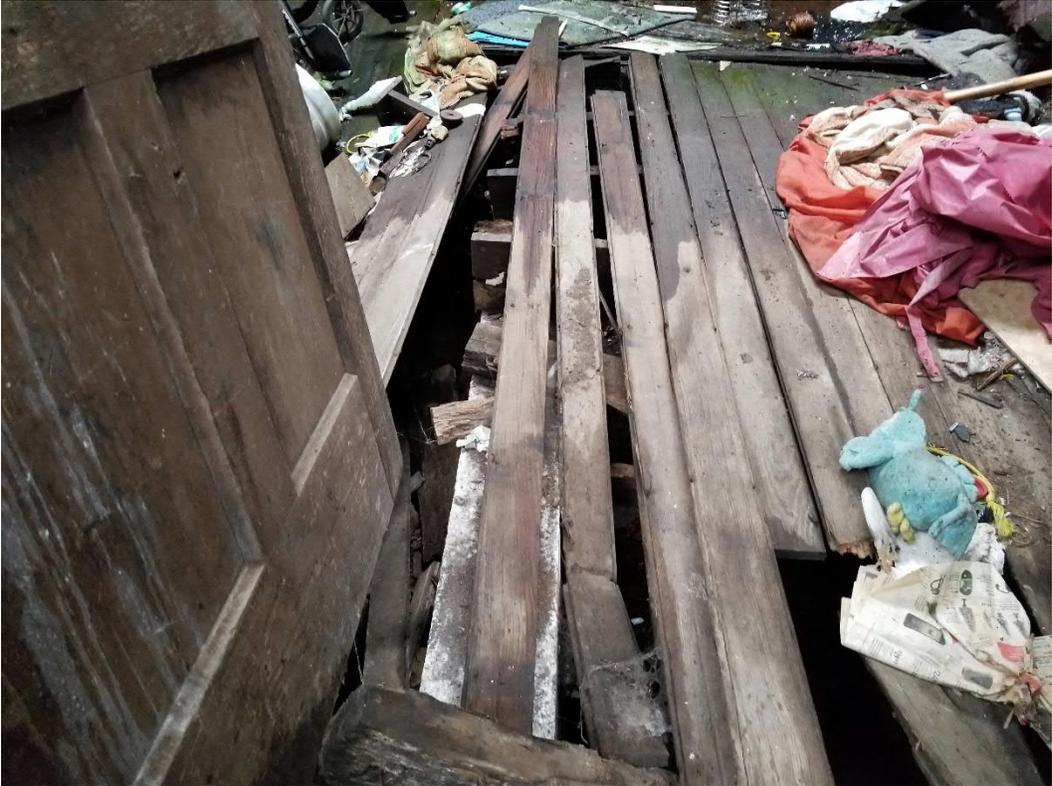
Floor in lower level, back half.

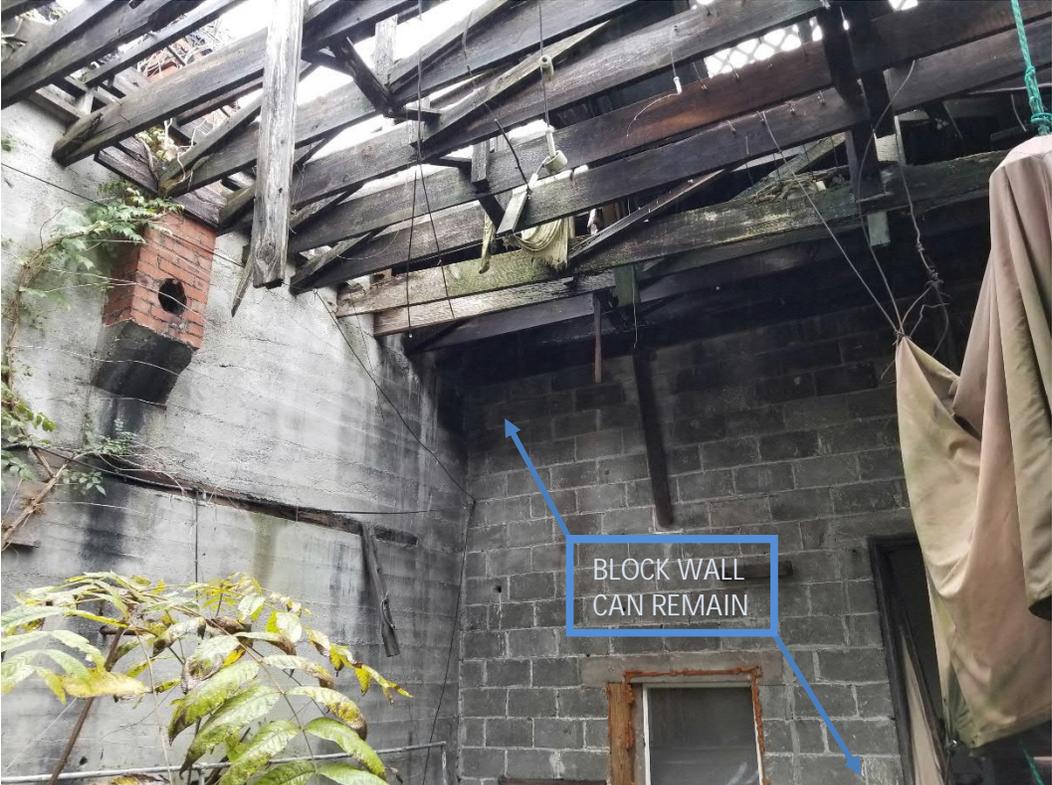
Roof in garage area.
